RADIOLOGICAL REMOVAL ACTION COMPLETION REPORT

Radiological Surveys of Buildings and Ground Surfaces, and Storm Drain and Sanitary Sewer Removal Parcel D-1, Phase 1 Hunters Point Naval Shipyard San Francisco, California

Document Control Number: SHAW-8822-0006-0435

January 2014

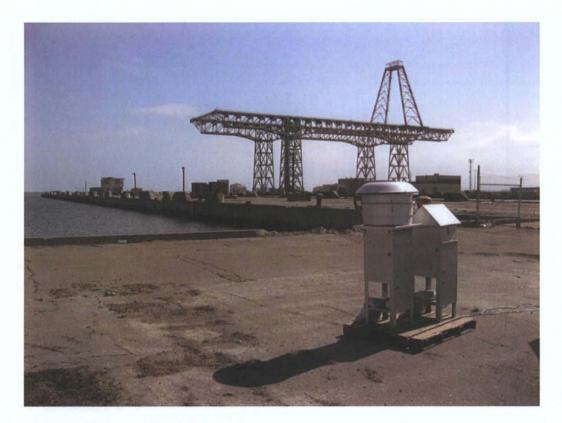
Photograph 1: Air Monitoring Station near South Pier, Facing South—October 7, 2010

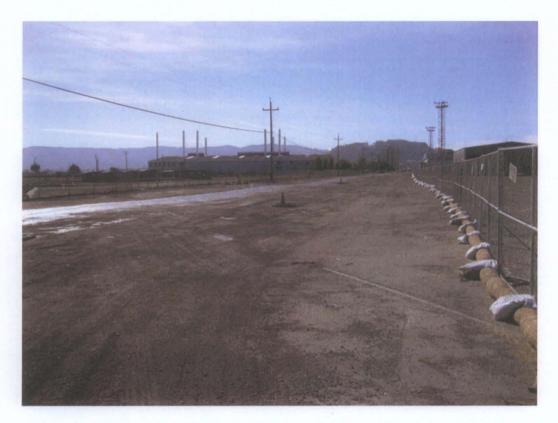
Photograph 3: Pre-Excavation Manseau Street, Facing Northeast—October 15, 2010

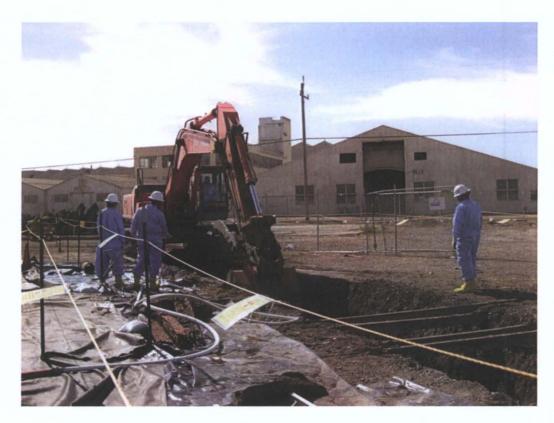
Photograph 5: Excavation at Trench Survey Unit 273—October 8, 2010

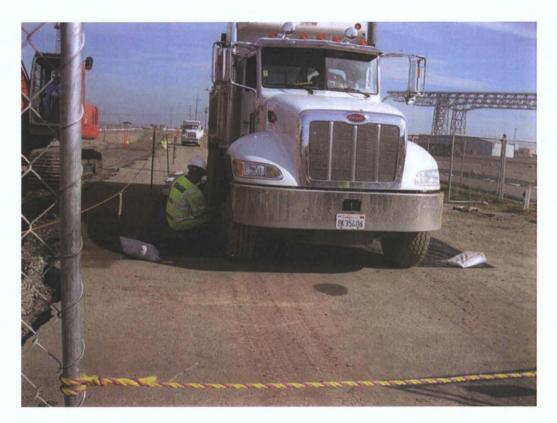
Photograph 9: Scanning out dump truck—November 3, 2010

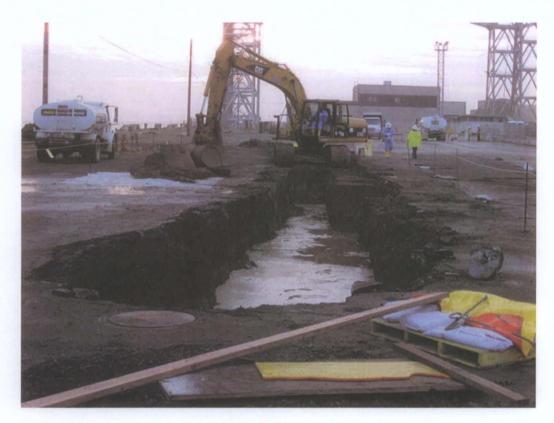
Photograph 11: Excavation along trench segment 06-D28-32-1F, facing southeast—December 3, 2010

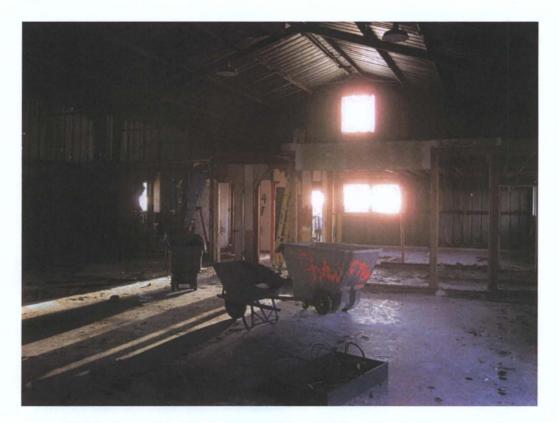
Photograph 13: Taking down the walls inside Building 274—December 7, 2010

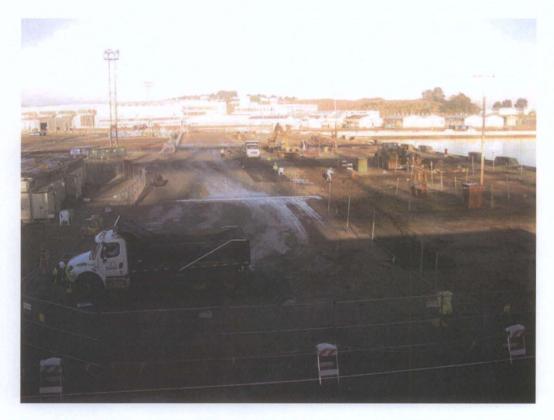
Photograph 15: Overview of trenching operation at Trench Survey Unit 262, facing northwest— December 7, 2010

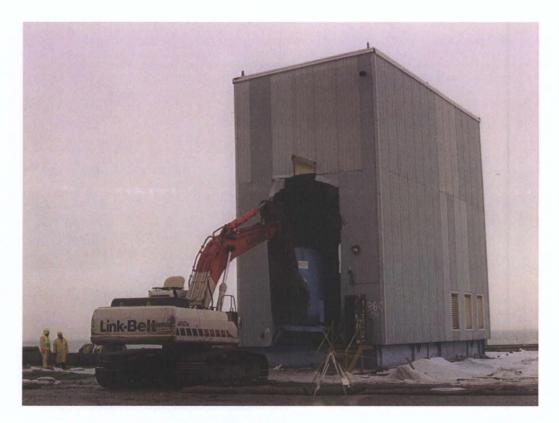
Photograph 17: Removing tank from Building 375, facing east—December 8, 2010

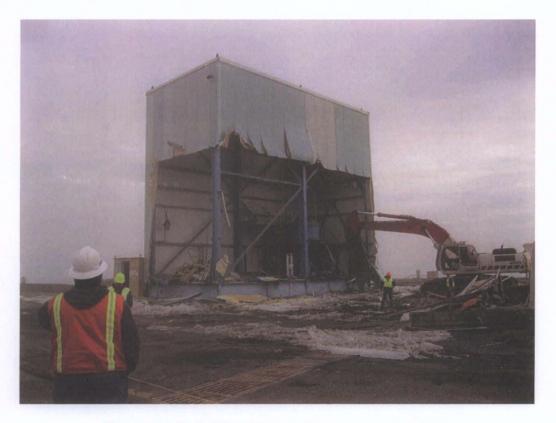
Photograph 19: Building 375 demolition—December 9, 2010

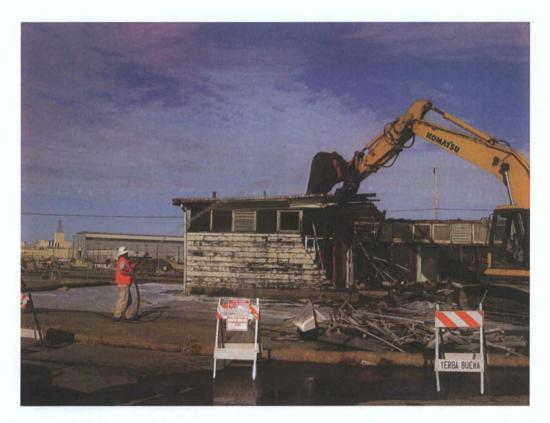
Photograph 21: Dust control during Building 370 demolition—December 15, 2010

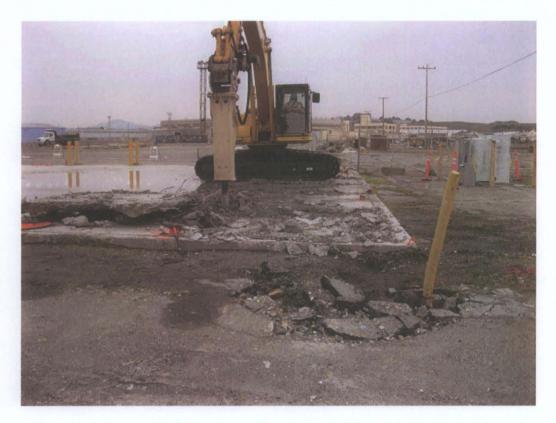
Photograph 27: Breaking Building 383 foundation, facing northwest—January 11, 2011

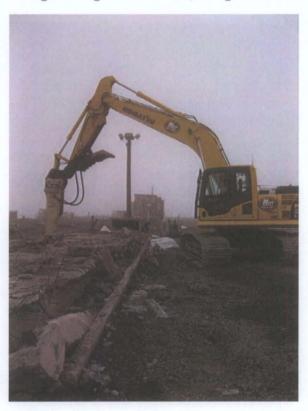
Photograph 28: Breaking Building 311 foundation and removing sewer pipes—January 17, 2011

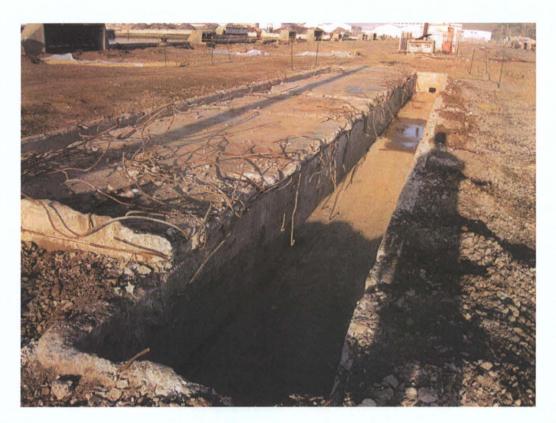
Photograph 29: Remains of Building 311 foundation with sewer pipe removed—January 24, 2011

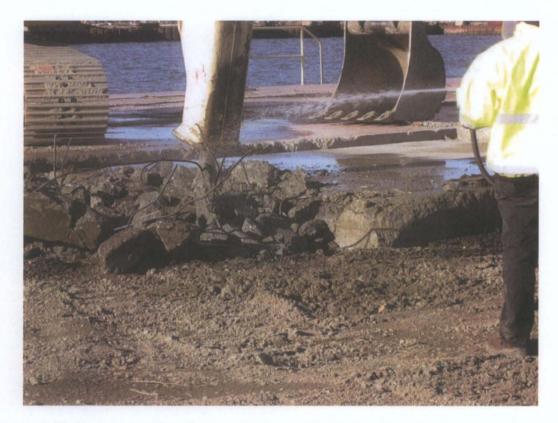
Photograph 35: Concrete breaking along trench segment 06-D29-00-11C, facing west—February 2, 2011

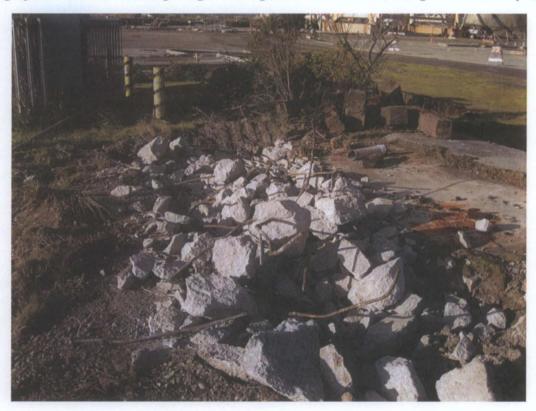
Photograph 36: Broken up concrete pad along trench segment 06-D29-68-1B, facing southwest—February 3, 2011

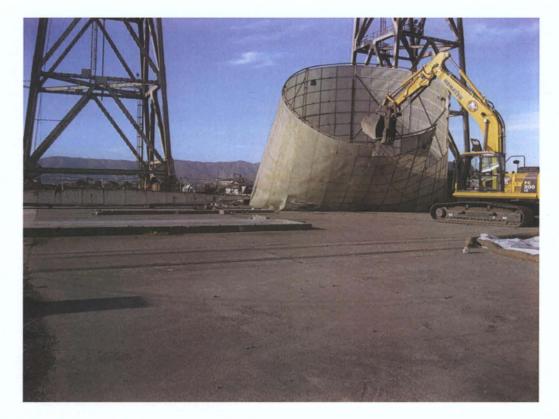
Photograph 37: Removing missile launch pad structure underneath Gun Mole Pier crane—February 3, 2011

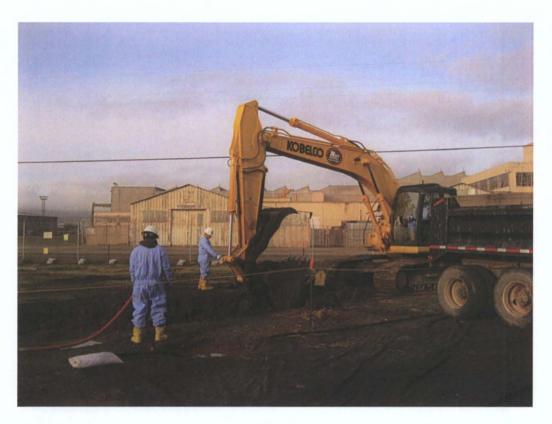
Photograph 41: Excavation along trench segment 06-D24-35-2A in Work Area (WA) 24—February 23, 2011

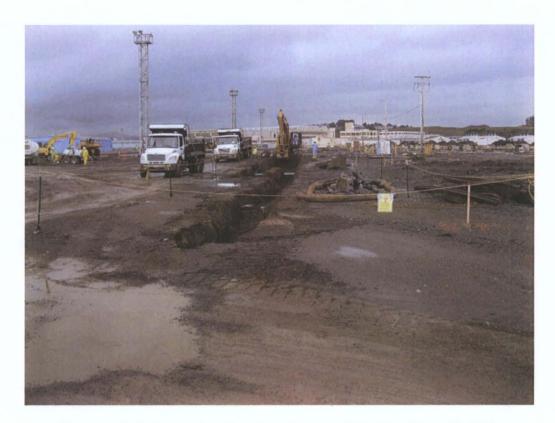
Photograph 45: Excavation along Trench Survey Unit 268—March 14, 2011

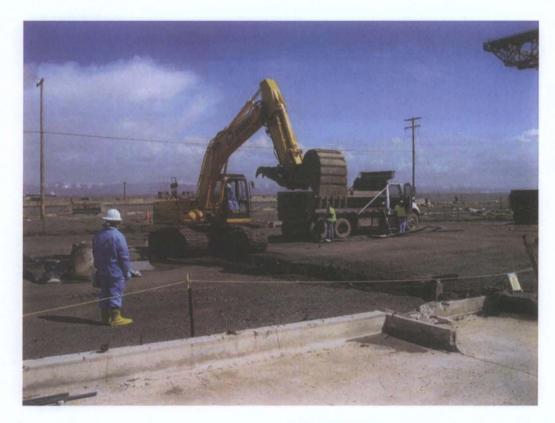
Photograph 47: Excavation along trench segment 06-D28-32-2G in WA 28—March 21, 2011

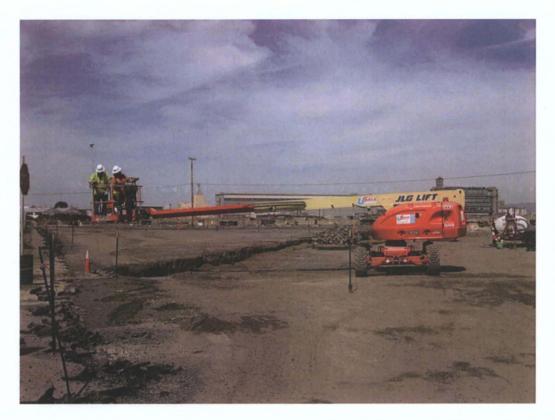
Photograph 49: Gamma scanning along trench segment 06-D28-32-1J in WA 28—April 1, 2011

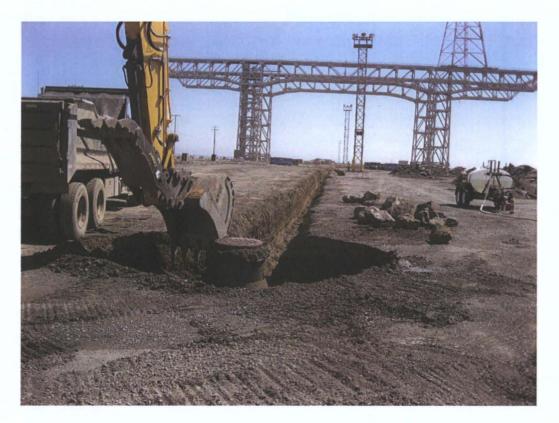
Photograph 57: Excavation around MH747 in WA 28—September 19, 2011

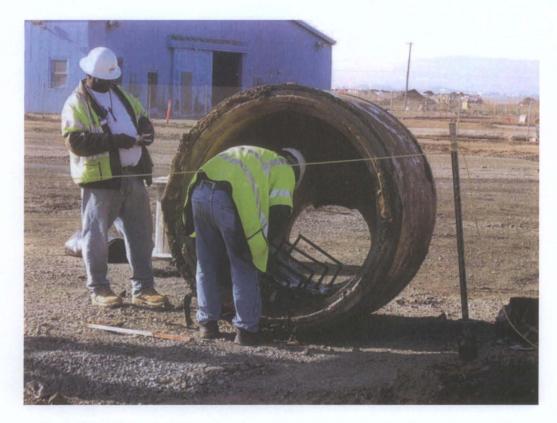
Photograph 59: Radiological scanning of a manhole in WA 28—September 26, 2011

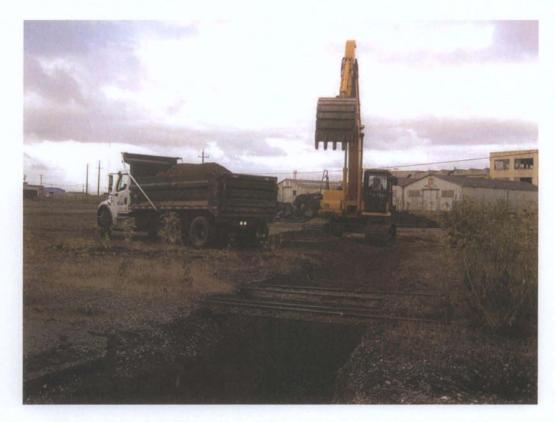
Photograph 63: Backfilling at Trench Survey Unit 273, WA 24—October 6, 2011

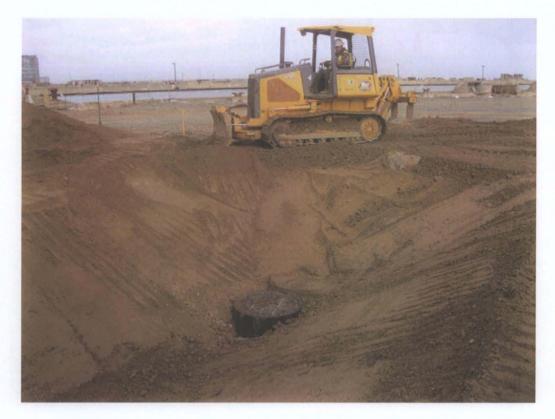
Photograph 75: Catch basin installed at northeast end of swale, near MH749—December 29, 2011

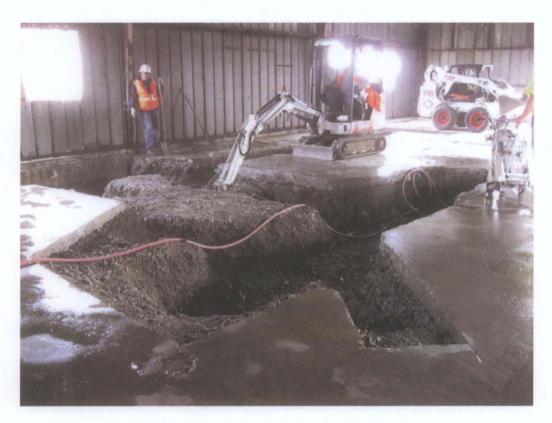
Photograph 87: Trenching inside Building 274—March 20, 2012

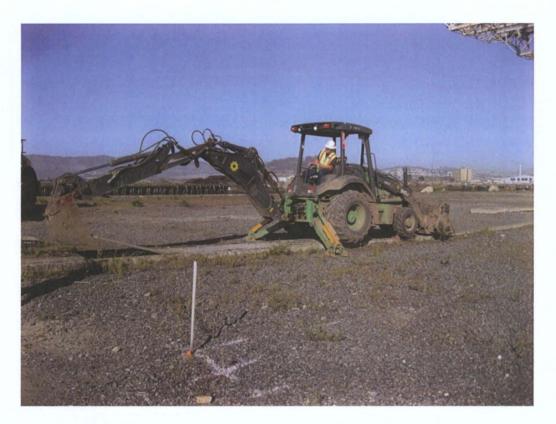
Photograph 89: Removing trench plates along GEC02 in WA 29—May 7, 2012

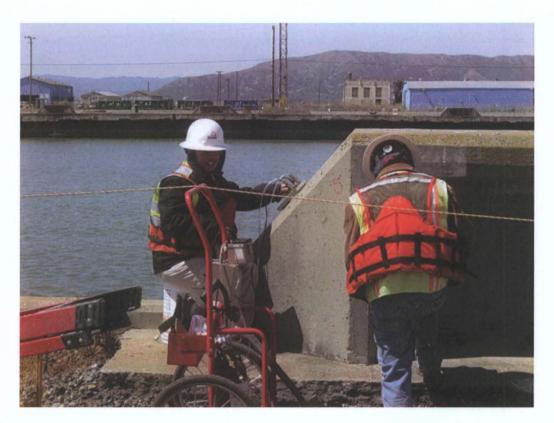
Photograph 105: Performing radiological survey on utility hood at South Pier—July 11, 2012

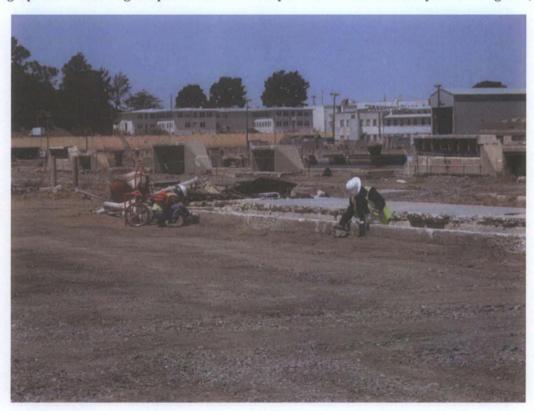
Photograph 108: Performing radiological survey on former Building 311 foundation, South Pier—August 13, 2012

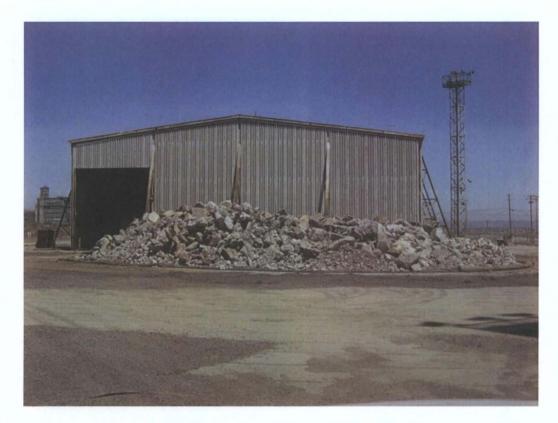
Photograph 109: Scanned and released concrete stockpile in Parcel G-August 7, 2012
